**RE: QUARTERLY PROGRESS REPORT FOR THE AVTEX FIBERS SUPERFUND SITE FOR THE
PERIOD APRIL 1 THROUGH JUNE 30, 2021 (SECOND QUARTER)**

Quarterly Inspection Report

Quarterly Inspection Report Photographic Log
Avtex Superfund Site
Front Royal, Virginia

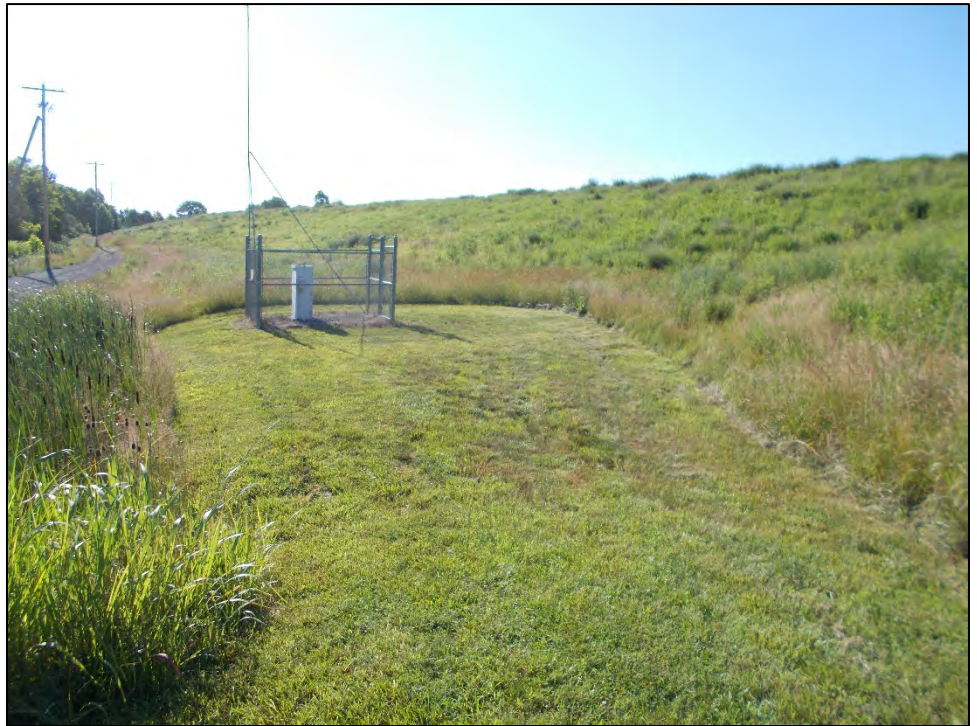
Photo Number: 1

Photo Description: Two areas of former standing water adjacent to LS-2 (dry).

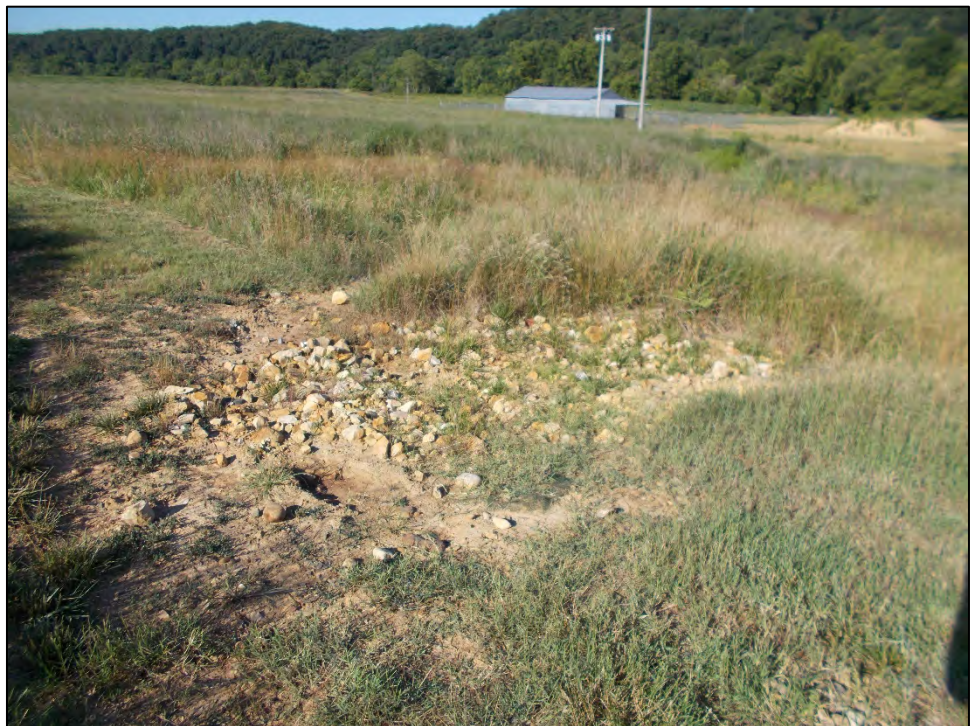
Photo Number: 2

Photo Description: Former standing water on access path west of VB-4,5, & 6 (path to LS-1)

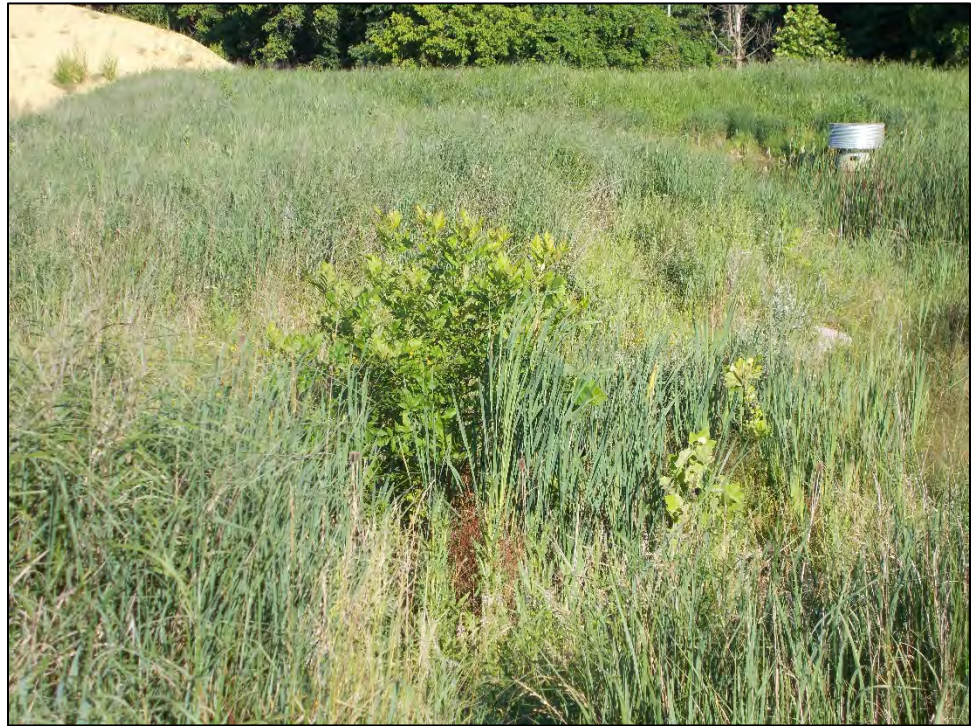
Photo Number: 3

Photo Description: Small tree growing in drainage ditch (currently less than 2-inch dia. or 5-feet high).

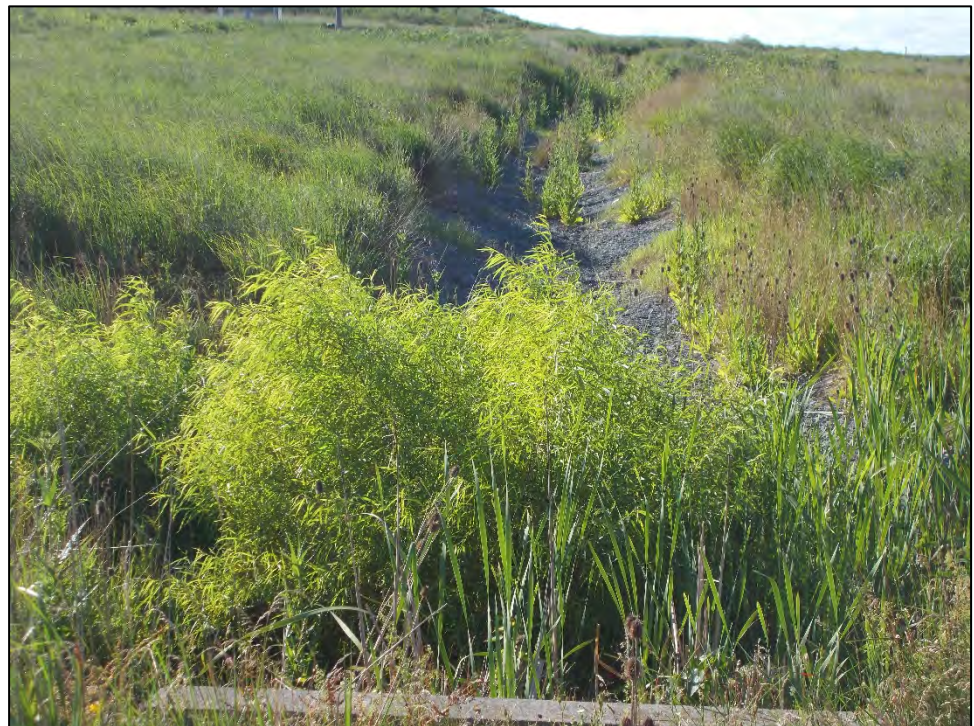
Photo Number: 4

Photo Description: Small trees in drainage ditch (currently less than 2" dia / 5' tall).

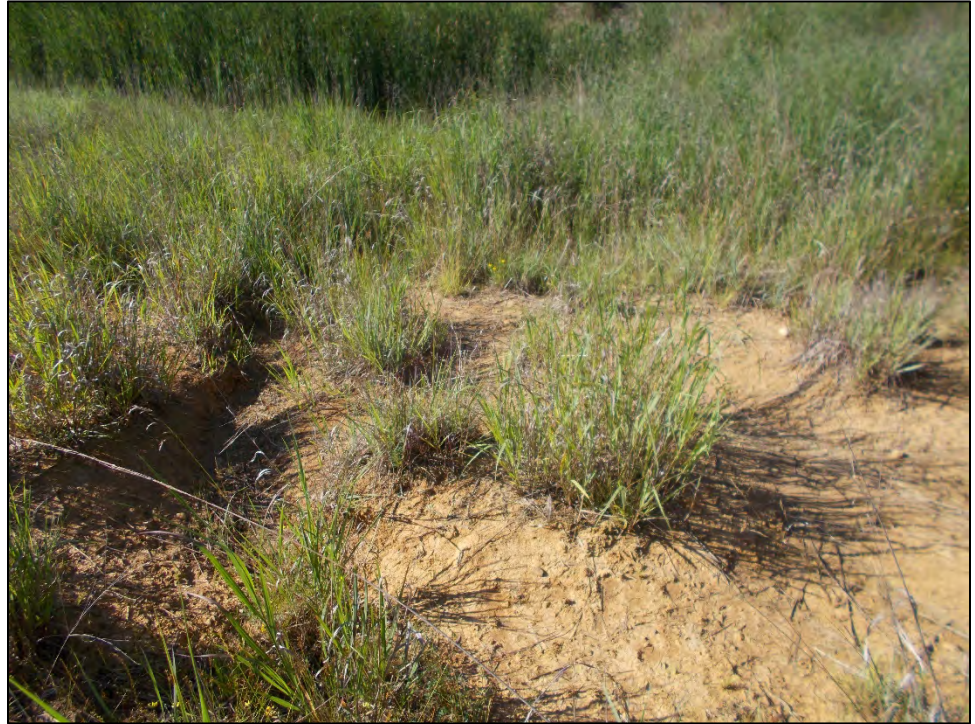
Photo Number: 5

Photo Description: Bare soil (~10' x30`) with rills southeast of VB-2&3 (Sediment basin between NLF and VB-2&3). Appears stable.

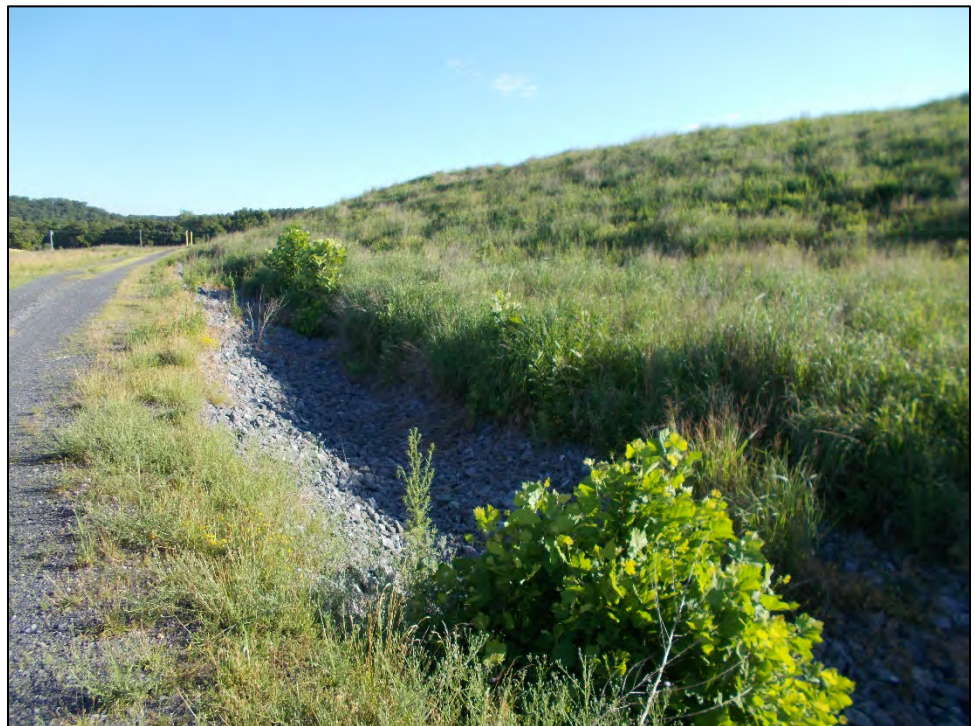
Photo Number: 6

Photo Description: Small tree growing in drainage ditch (currently less than 2-inch dia. or 5-feet high).

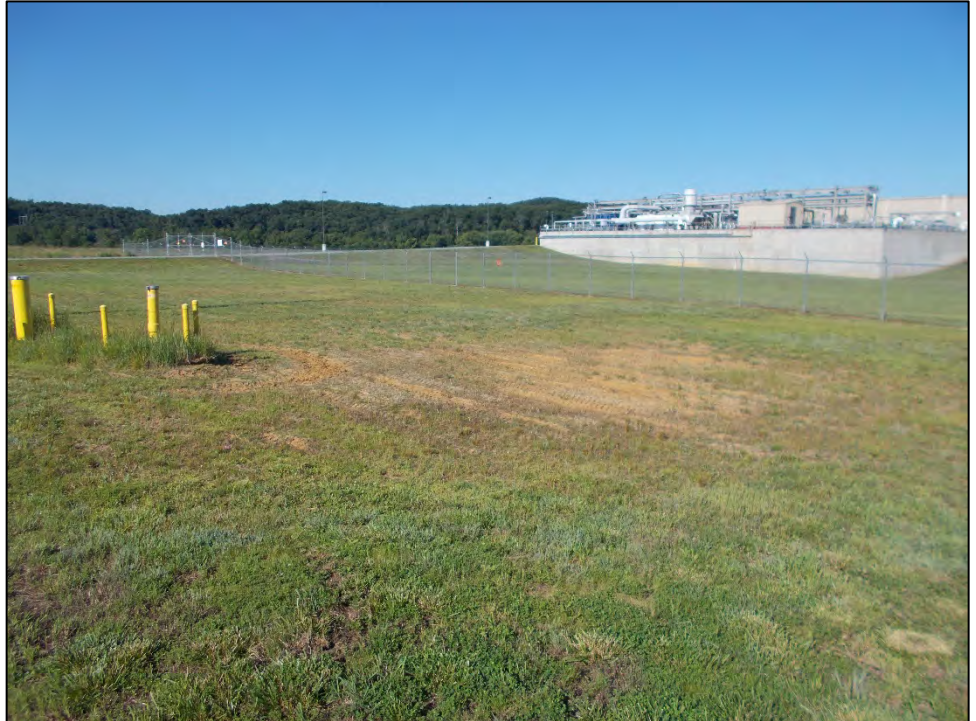
Photo Number: 7

Photo Description: Area around wells 103/203/303 – dry.

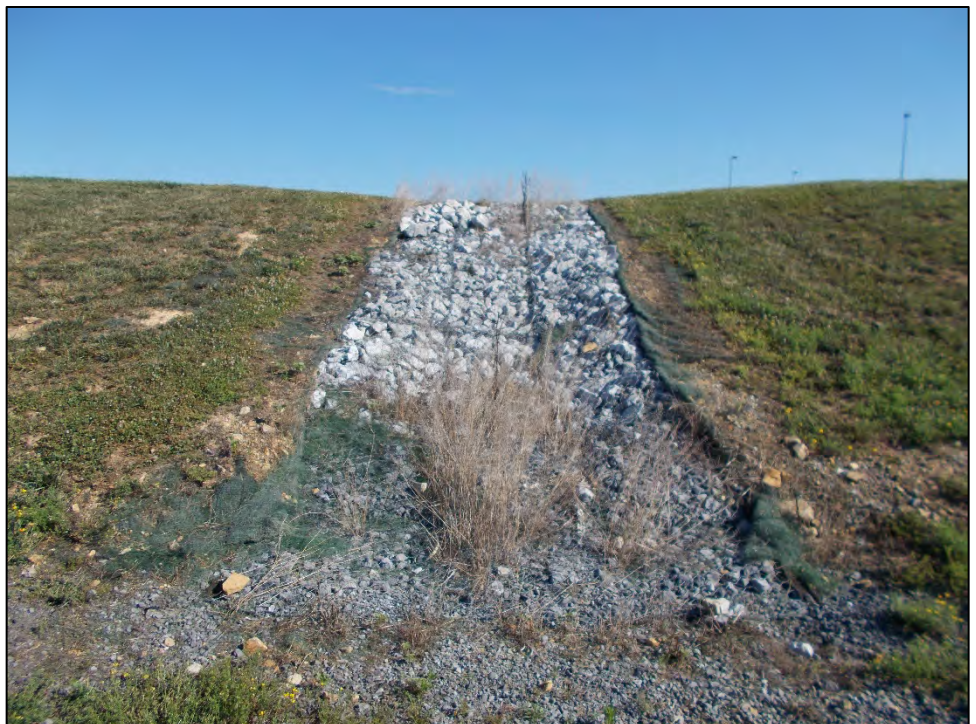
Photo Number: 8

Photo Description: Bare patches and exposed matting at down chute in south side of VB-10.

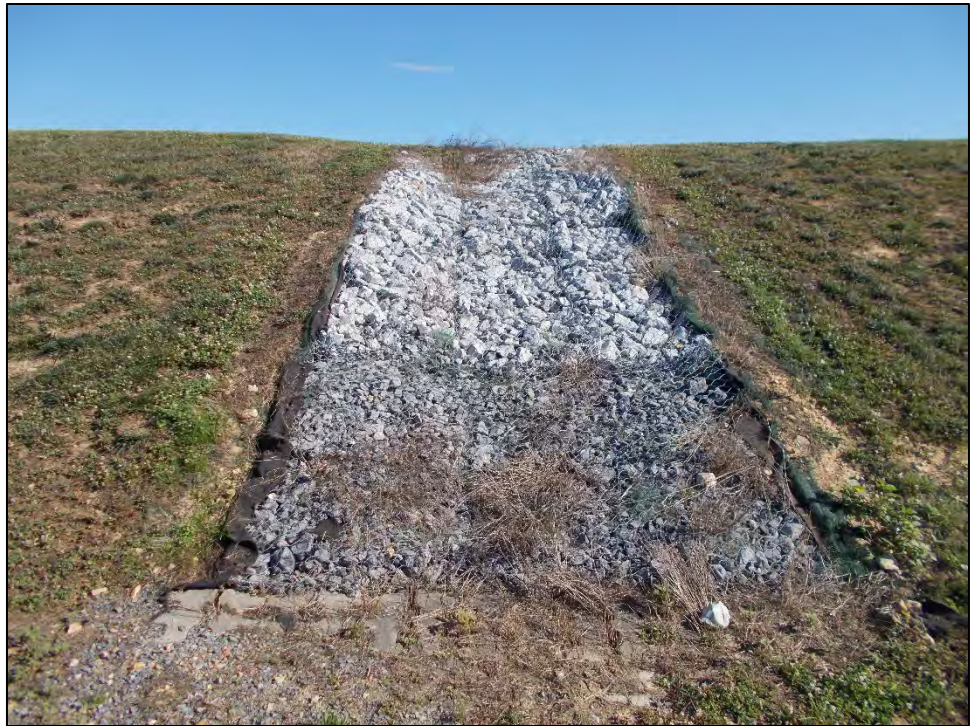
Photo Number: 9

Photo Description: Bare patches and exposed matting at down chute on south side of VB-10.

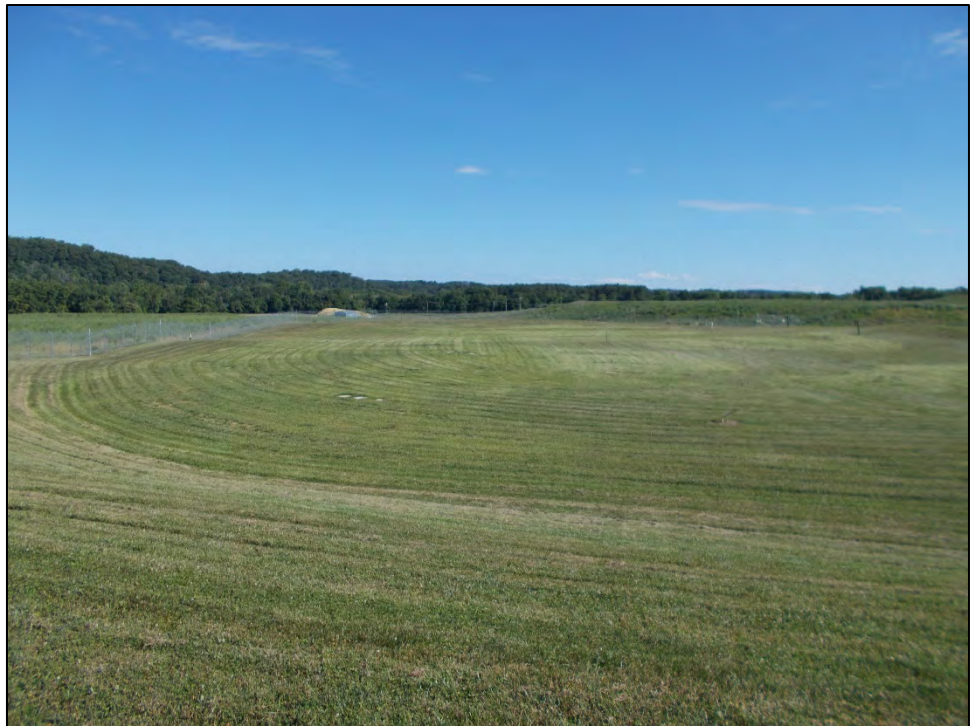
Photo Number: 10

Photo Description: VB-9 after repairs.

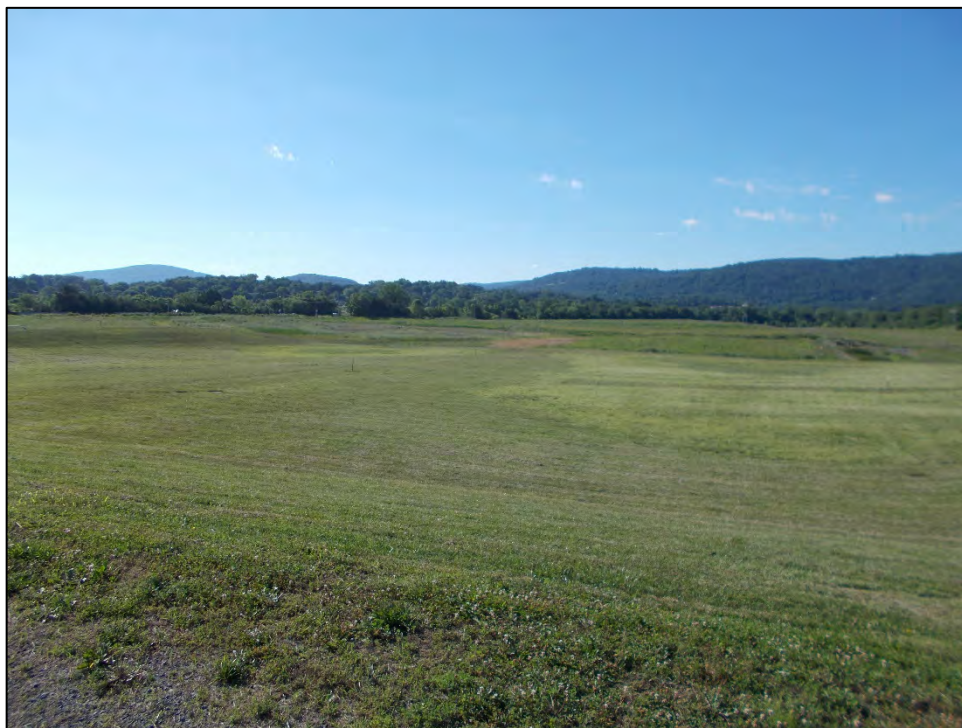
Photo Number: 11

Photo Description: VB-10 after repairs.
